Manhole Inspection Summary

Manhole # S31EE_011MH

Insp Date: **1/19/07 11:01 AM**

Location Address: **253 DOLPHIN ST**

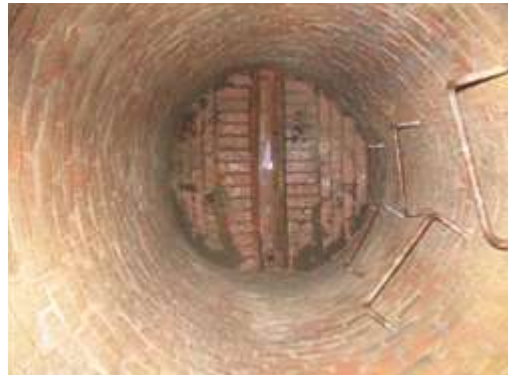
Top View

Bench debris.

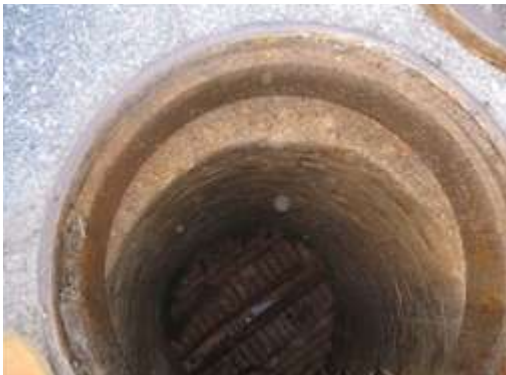
Defect

Frame Offset: **6** (in.) Condition: ☐ Sound ☐ Cracked ☒ **Leaks**

Frame offset.

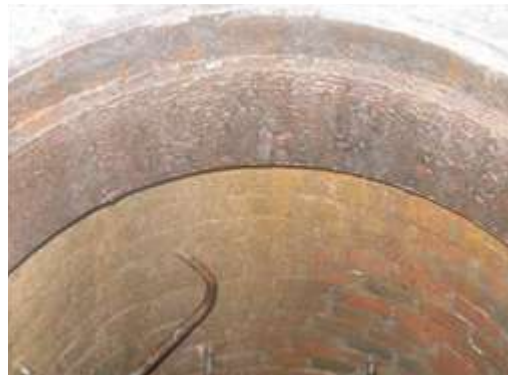
Defect

Infiltration: ☐ None ☐ Joint ☐ Cracks ☒ **Mortar** ☐ Roots ☐ Wall

Frame leaks. Adjustment infiltration - other side.

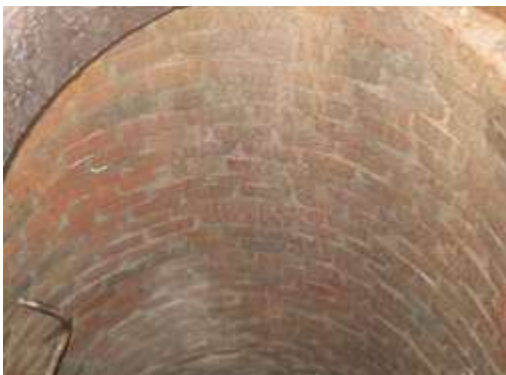
Defect

Frame leaks. Adjustment infiltration.

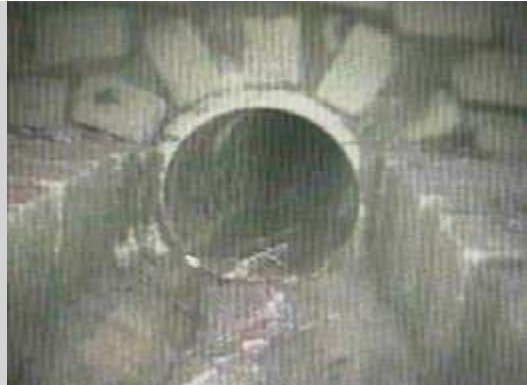
8 in. Circular Gravity Sewer Pipe Out @ 12 O'Clock

Deposits: ☐ None ☐ **Mud** ☐ Sludge ☐ Debris ☒ **Grease**

Silt Depth: **0** (in.) Deposits Extent: **Light**

Infiltration: **Evidence** Pipe Seal Cond: **Unknown**

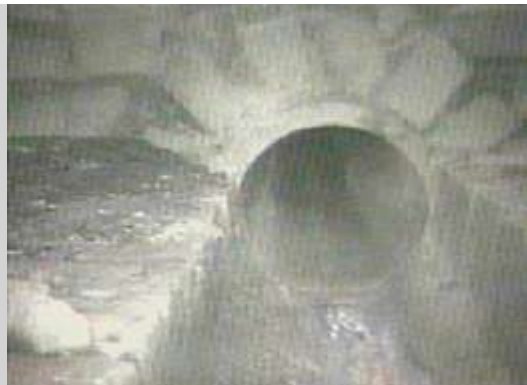
8 in. Circular Gravity Sewer Pipe In @ 6 O'Clock

Deposits: ☐ None ☒ **Mud** ☐ Sludge ☐ Debris ☐ Grease

Silt Depth: **0** (in.) Deposits Extent: **Light**

Infiltration: **Evidence** Pipe Seal Cond: **Unknown**
